| <b>HISTORIC RESOURCES INVENTORY</b><br><b>BUILDING AND STRUCTURES</b><br>HIST-6 REV. 01/06<br><br>STATE OF CONNECTICUT<br>COMMISSION ON CULTURE AND TOURISM<br>59 South Prospect Street, Hartford, Connecticut 06106<br>(860) 566-3005 | | | | <i>FOR OFFICE USE ONLY</i> | | | | | | | | | | | | | | | | | | | |
| 1. BUILDING NAME (Common)<br>Twitchell-Rowland Homestead | | | | | | | | | | | | (Historic)<br>Joseph Twitchell Homestead | | | | | | | | | | | |
| 3. STREET AND NUMBER (and/or location)<br>116 Christian Street | | | | | | | | | | | | | | | | | | | | | | | |

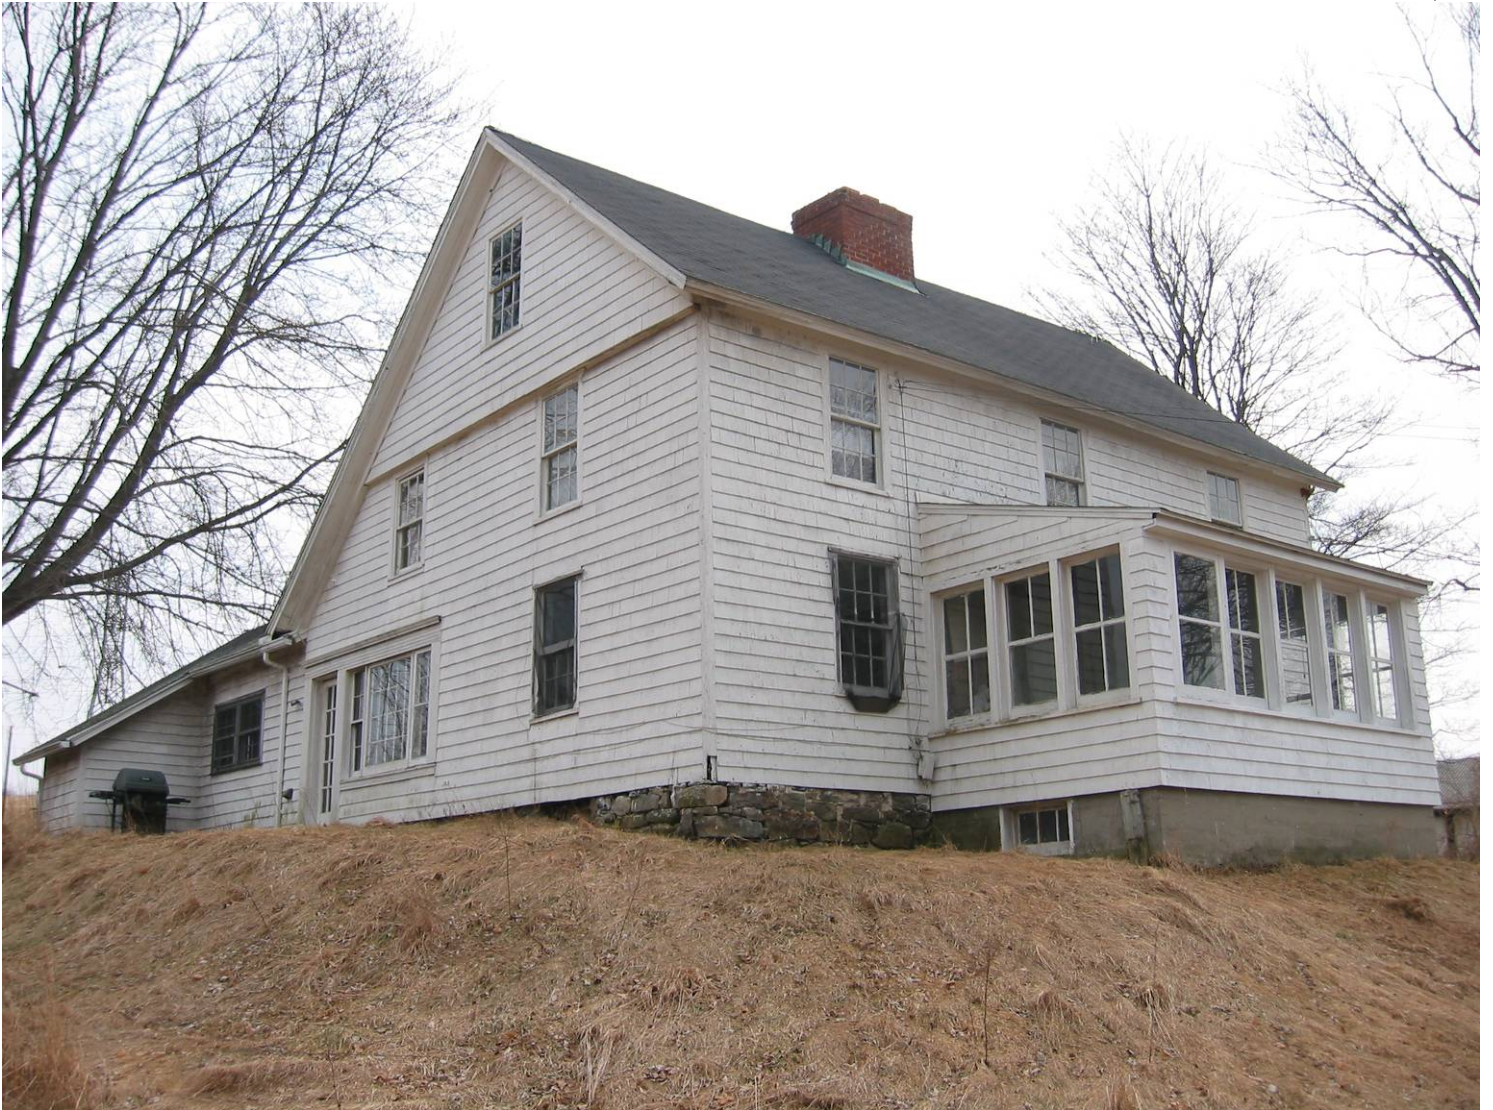
Figure 2 – The Joseph Twitchell Homestead from the northwest.

The Joseph Twitchell Homestead is a 2.5-story integral leanto house with an ell and enclosed modern front porch that sits on Christian Street, looking west down Towner Lane, in the northeastern part of Oxford. (Figures 1-3) It was constructed ca. 1755. Despite subsequent additions, the main block's size, shape, pattern of fenestration and the location of its chimney all identify it as a product of the 18<sup>th</sup> century.

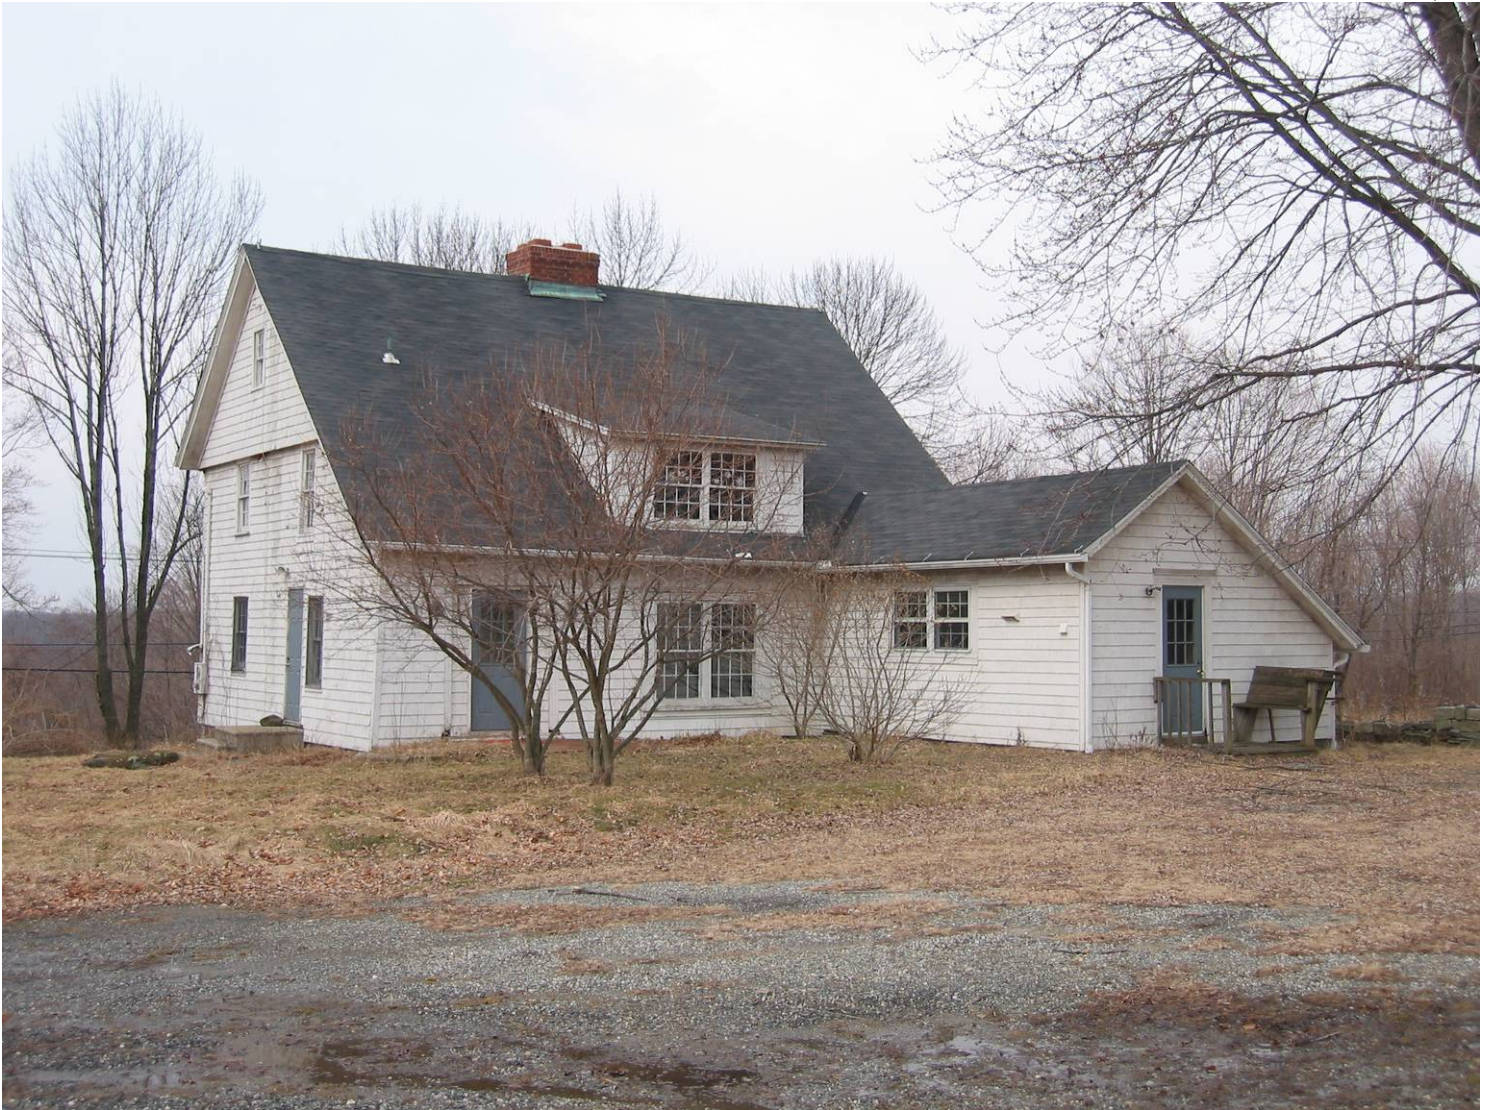
Figure 3 – The Joseph Twitchell Homestead from the southeast.

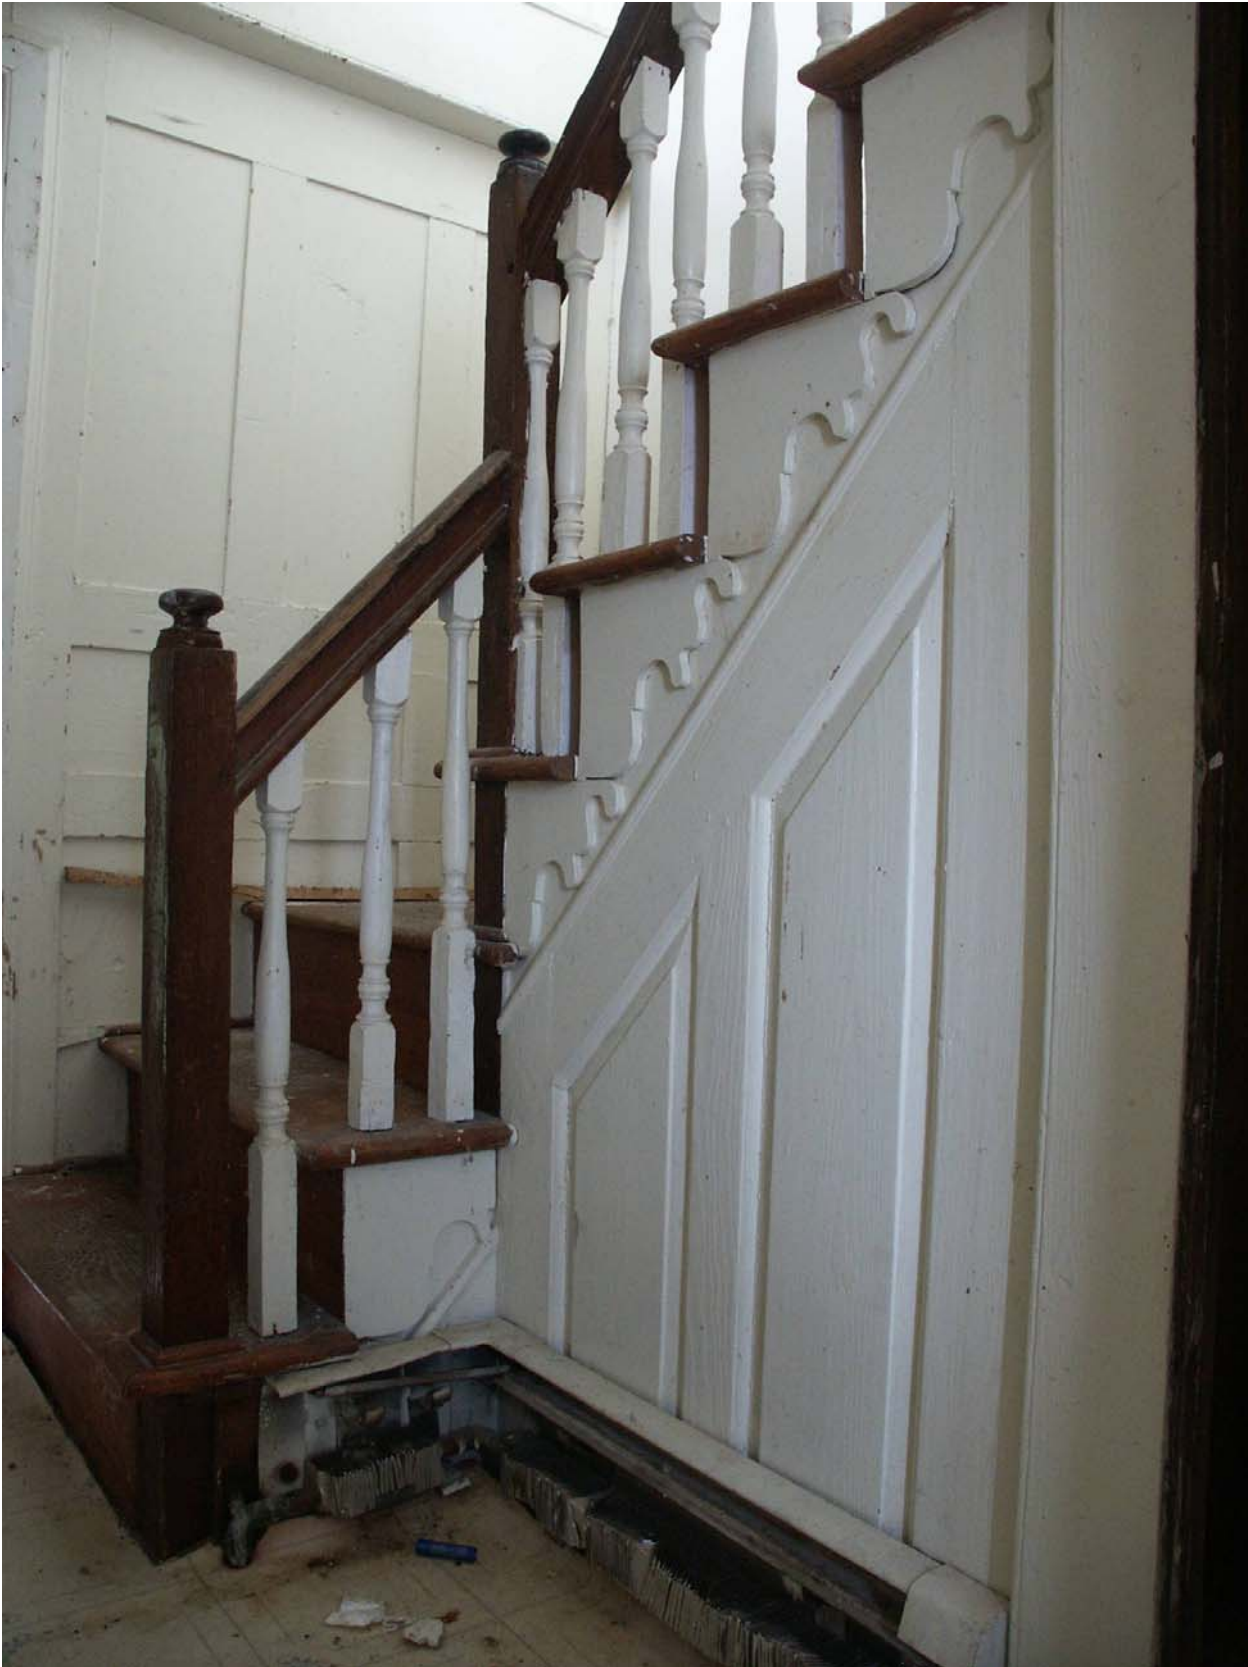
While the front door was replaced during the 19<sup>th</sup> century much of the rest of the material in the stair hall appears to date to the construction of the building ca. 1755. The open stringer stairs rise in three runs to the second floor; the central run sits atop a paneled wall. The molded banister sits on turned balusters with sawn decorations on the end of each stair. (Figure 4)

Figure 4 – The front stairs from the southwest.

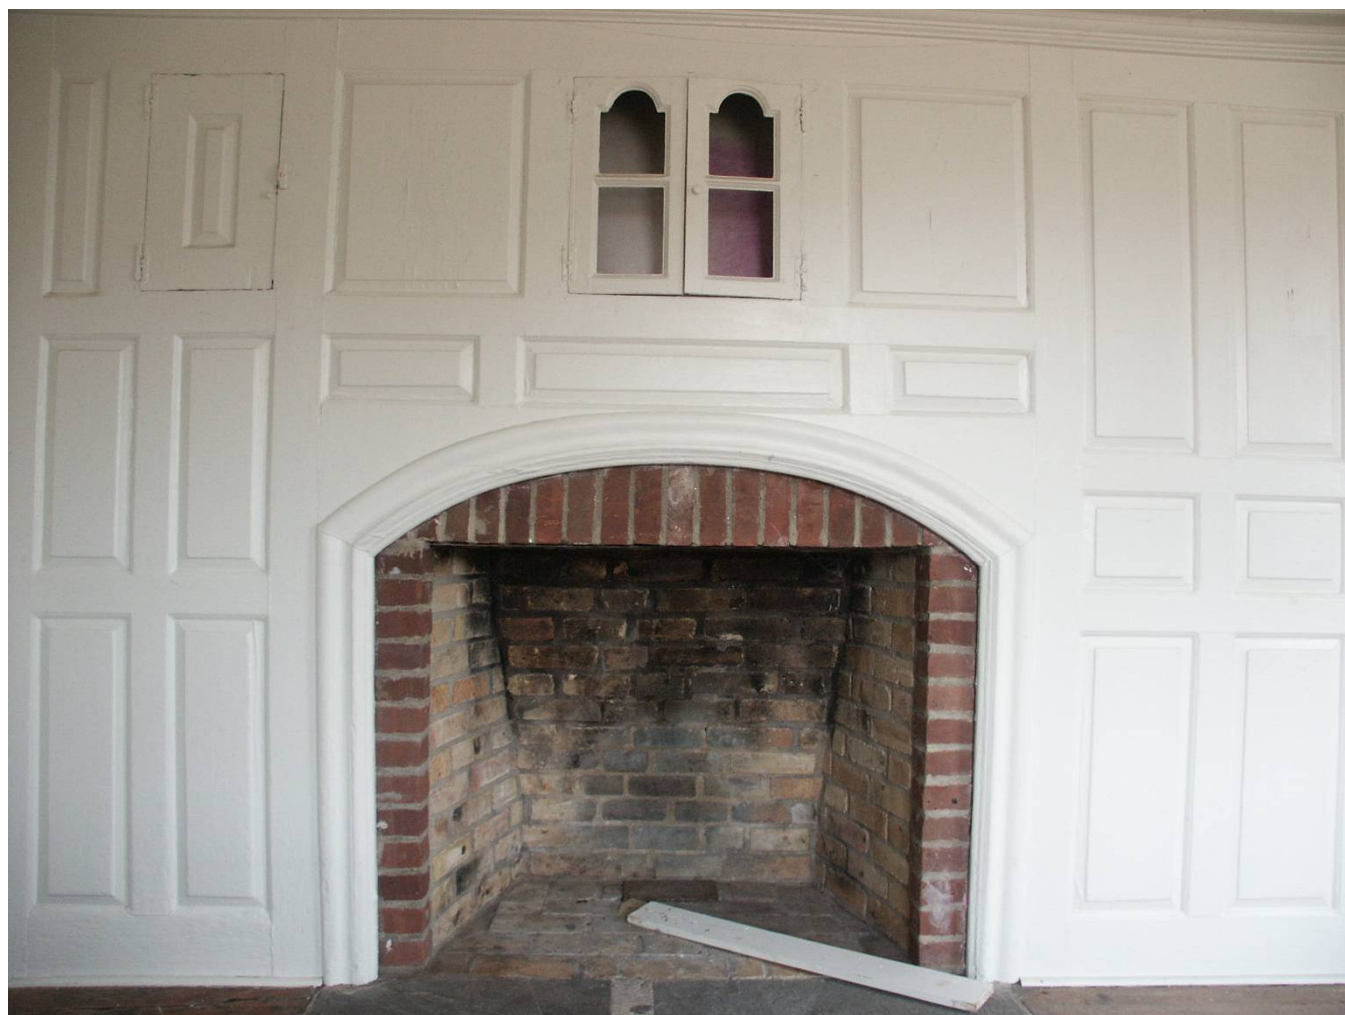
Both the northwestern and southwestern rooms on the first floor feature elaborately paneled fireplace walls with arch-topped fireplace openings decorated with bolection moldings. (Figures 5 and 6) In the southwestern room the other walls are decorated with paneled wainscoting; in the northwestern room there is a chair rail. The posts and girts are visible and cased in each room. No summer beam is visible in either room.

Figure 5 – The fireplace wall in the northwestern room from the North.

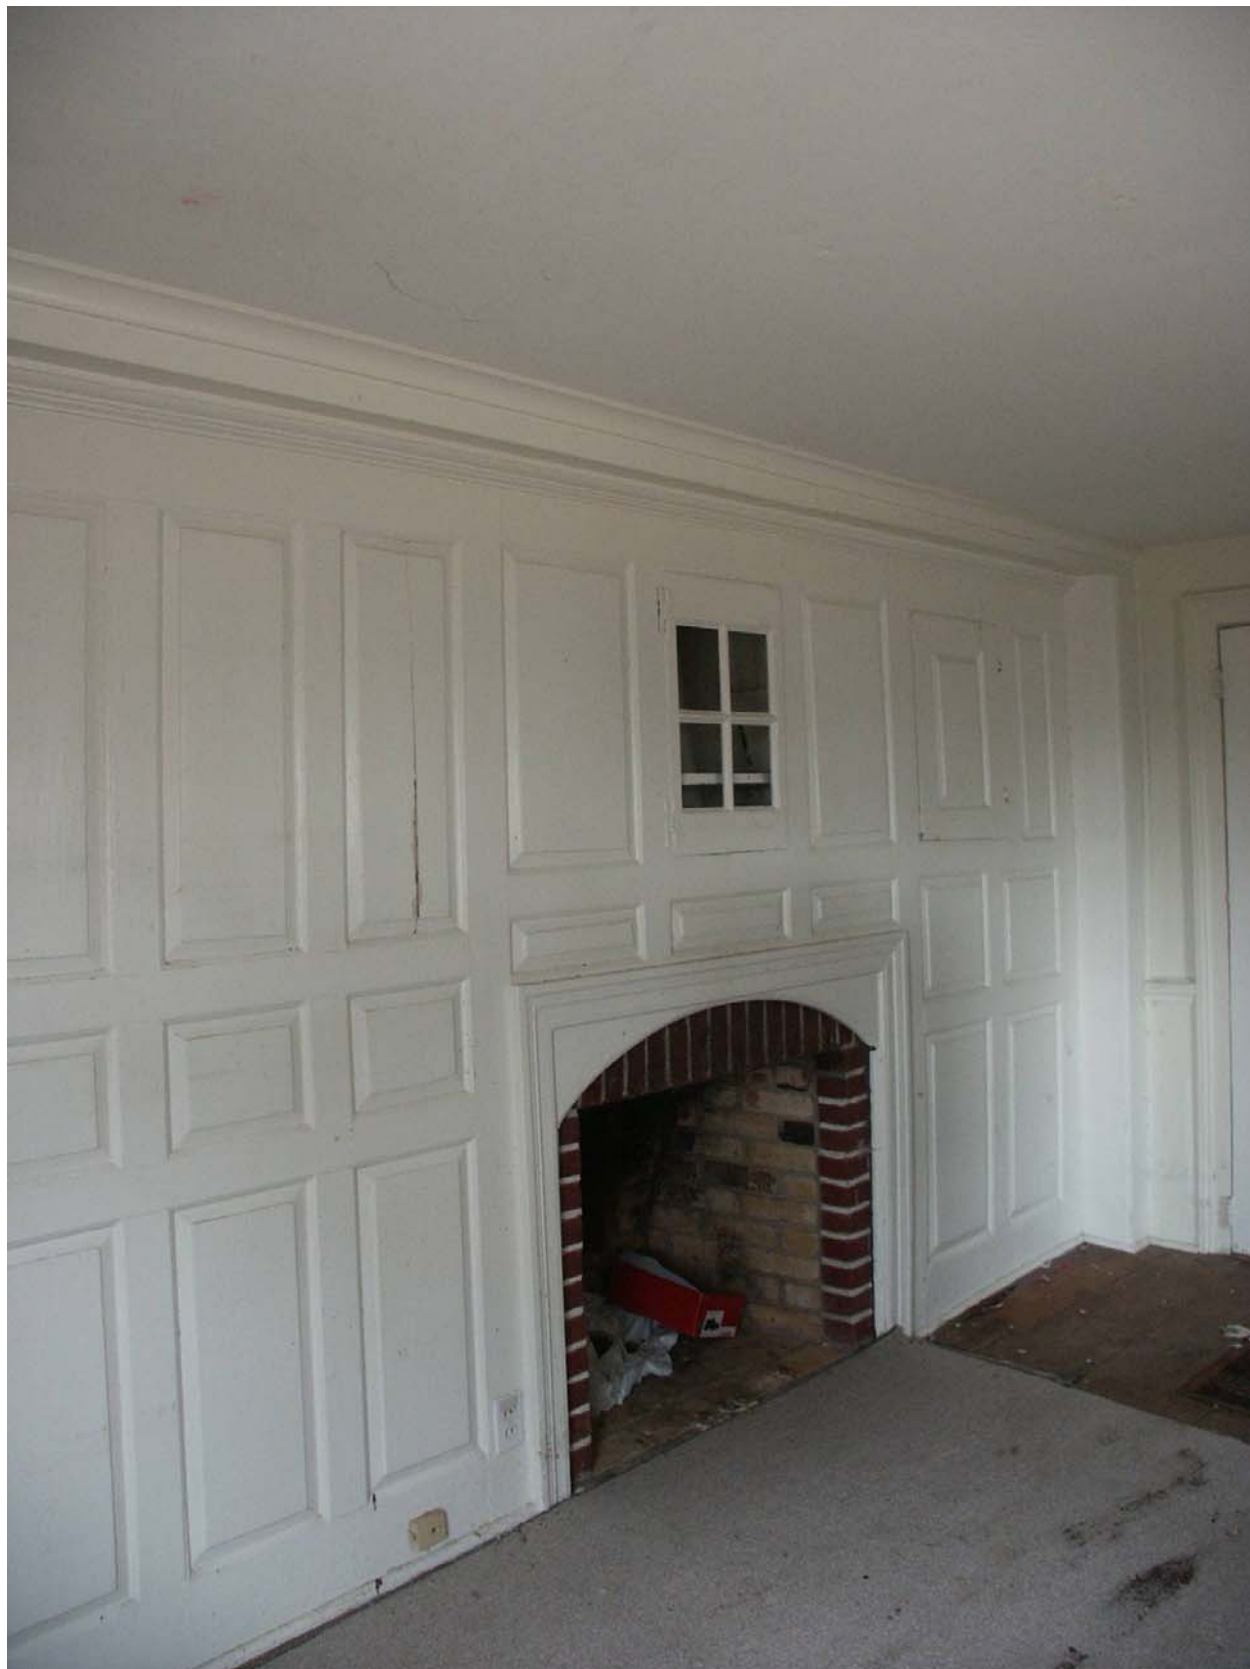
Figure 6 – The fireplace wall in the southwestern room from the southwest.

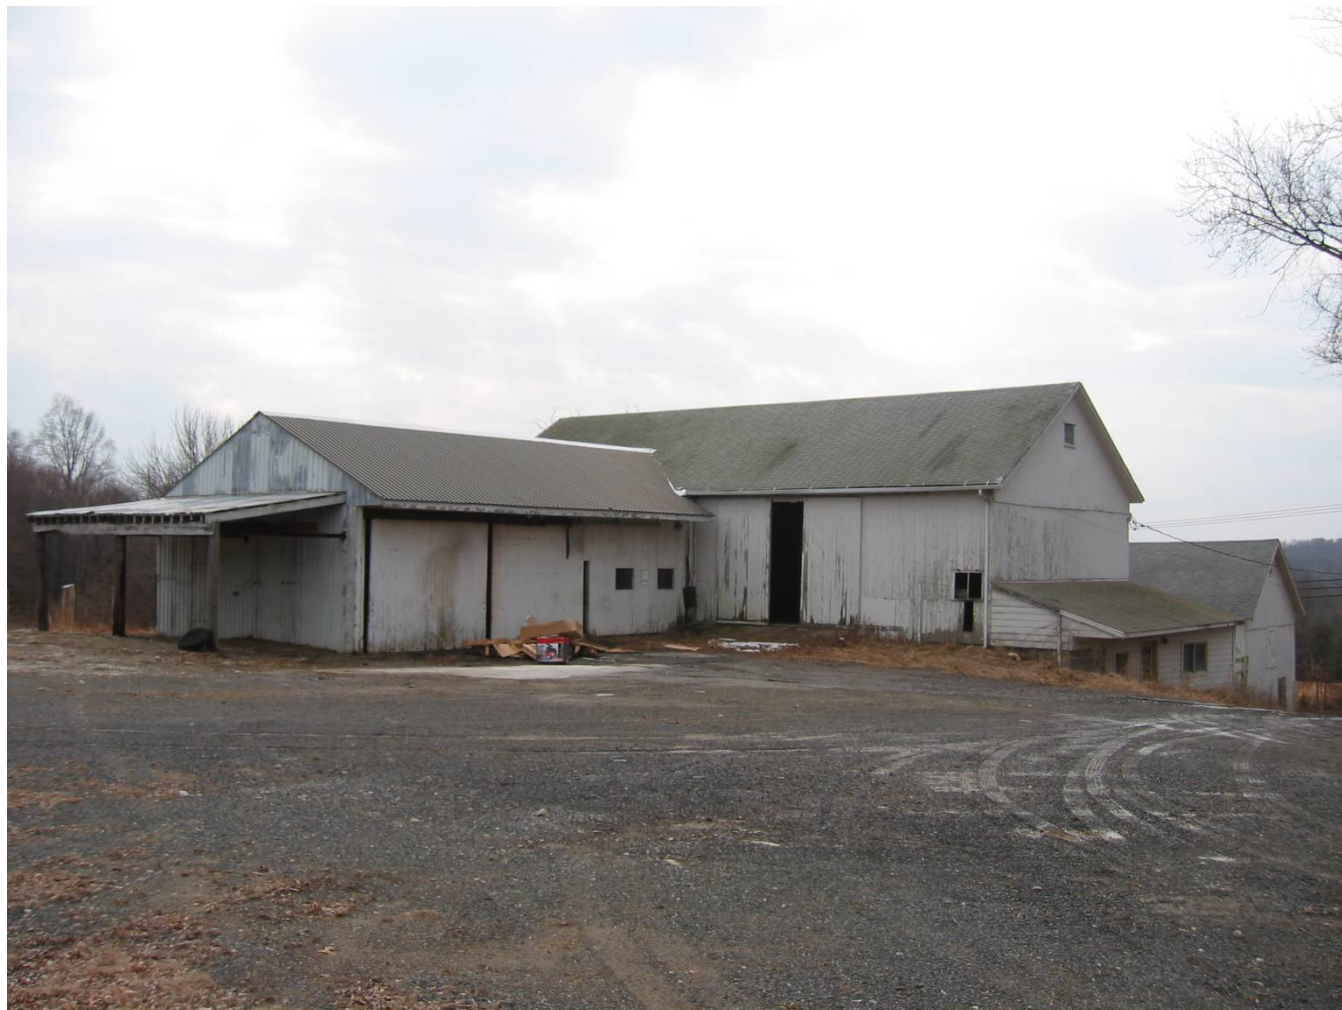
There are two historic outbuildings on the Twitchell Homestead property, both barns. (Figure 7) The more easterly, or upper, barn was constructed as a three-bay side-entry (or English) bank barn during the middle of the 19<sup>th</sup> century. (Figure 8) The original barn of roughly 30' by 40' was expanded in four building campaigns. The first involved the addition of another bay to the south, lengthening the building along the ridge. Next, a small ell was added to the east of the structure. During the 1930s this small ell to the east was replaced with the current shed which was formerly used for equipment storage. Finally, a small pent roofed addition was run across the lower level of the barn at the northern end. This provided additional space in the lower level of the barn, and new access to this space. The barn is covered in vertical siding and has an asphalt shingle roof. There are sliding doors on the eastern side of the main block; the ell has doors opening to the north.

Figure 8 – The “upper” barn.

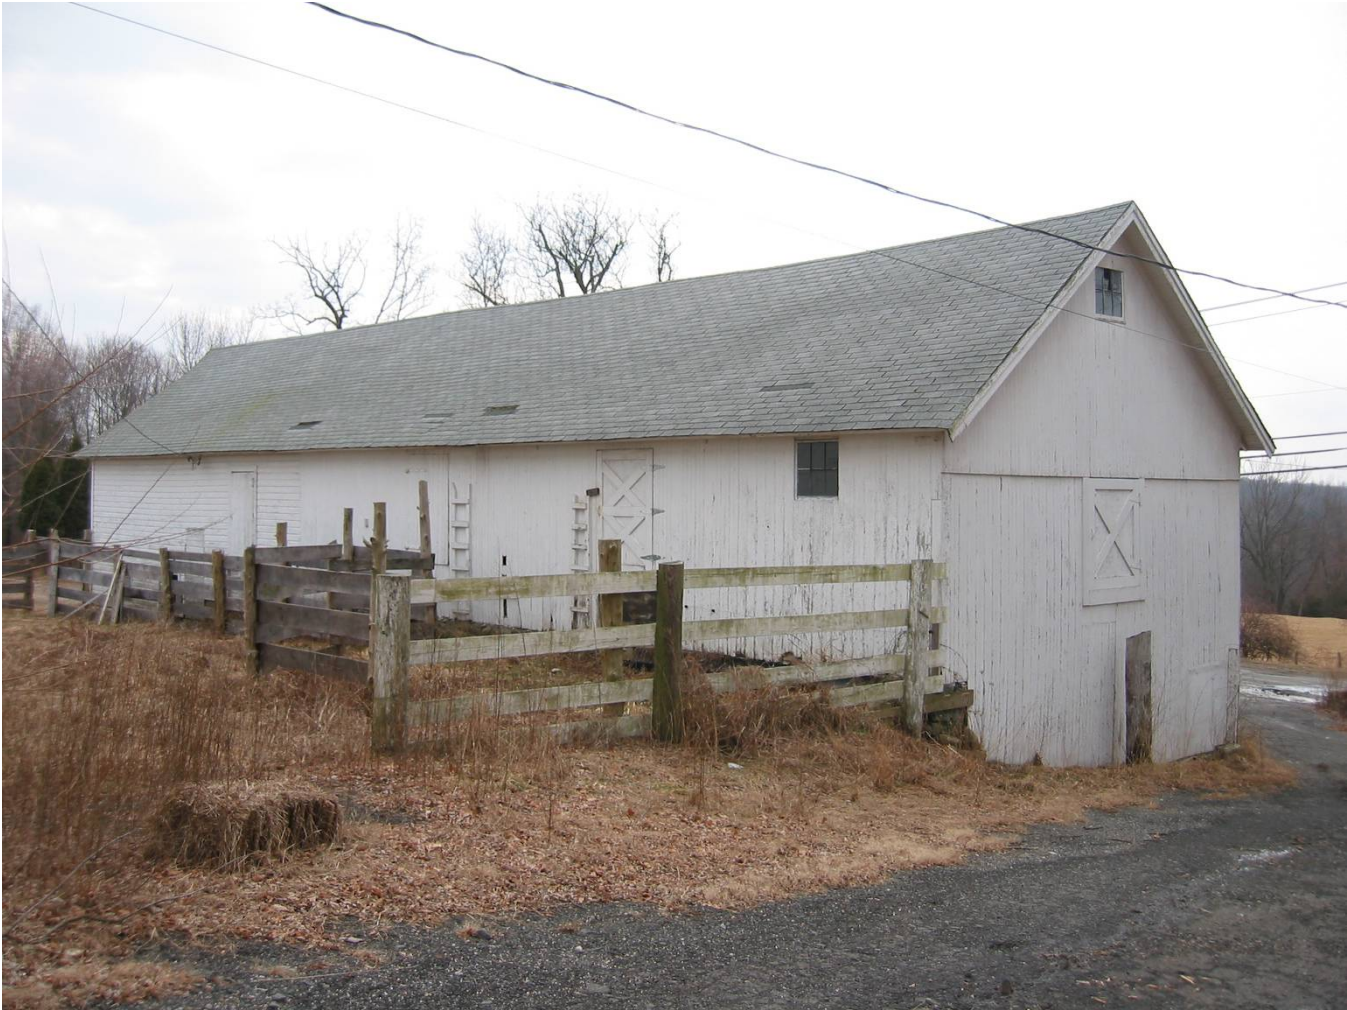
The second barn is also from the 19<sup>th</sup> century, although it appears to have been built toward the end of that period. (Figure 9) While rectangular in shape, it is a narrower and longer structure than the upper barn. It, too, is built into the hillside. Its eastern side is one story while its western is two. This barn was also expanded along its long axis. This expansion was undertaken during the 1930s when the Rowland family was trying to make their farm more productive.<sup>1</sup> The barn is covered in a combination of vertical sheathing and clapboards. It is roofed with asphalt shingles.

Figure 9 – The “lower” barn.
